# Report on the seismic reinforcement work of Sagamihara Sedimentation Basin

Construction Section, Facilities Department, Yokohama Water Works Bureau  
SUZUKI, Tomomi

Sagamihara Sedimentation Basin is a structure of the earth-fill dam type for removing suspended solids in raw water via deposition. In FY 2011, the bank was inspected for seismic resistance. The inspection showed that the main bank lacked the required seismic resistance on the side facing the basin (referred to as the “upstream face”).

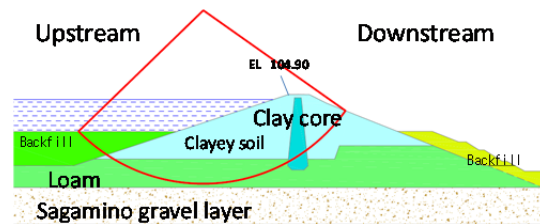
Fig. 4.1 Representative slip surface on the upstream face

The seismic diagnosis showed that the main bank did not have the required seismic resistance against Level 1 earthquake motion at the slip surface on the upstream face that passes through the downstream slope (Fig. 4.1).

It was judged difficult to retrofit the slip plane (Fig. 4.1) that did not have the required safety factor on the upstream side (Plans A, B, and C).

Therefore, a method was investigated that involved increasing the resistance of the slip surface on the downstream face to ensure the required safety factor (Fig. 5.1).

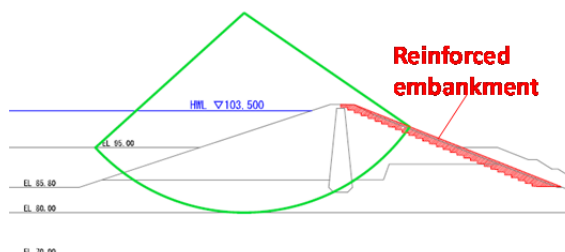
Fig. 5.1 Schematic sectional view of the retrofit plan

This method improves the downstream slope where the slip surface passes through, increases the cohesion and thus enhances the resistance along the slip surface.

The downstream slope was decided to be improved through reinforced embankment by replacement. The method involves replacing the surface soil of the downstream slope with reinforced embankment. The uniaxial compressive strength of the reinforced embankment was increased by mixing cement to the excavated surface soil. The method has the following advantages among others:
