The Damaged Water Supply Facility for Repair or Reconstruction Evaluation Program – A Case Study of Nao-Guan Service Reservoir at Taichung, Taiwan

Case study : The renovation proposal of Nao-Guan storage tank.

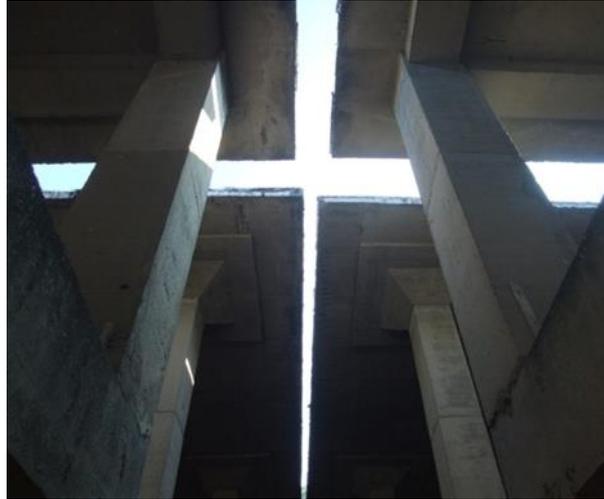
The main damage patterns of Nao-Guan reservoir are relative displacement damage produced from expansion joint and stress damage of beam-column joint, as shown picture 1-4. It can be seen that there is an obvious crack and disturbance near ground. This is because reservoir is located near geological fault zone. The maximum crack width from basin wall relative displacement is around 1 m, it can be passed through by one man. Many foundations displacement happened and then resulted in base slab rupture when there is an earthquake due to the single footing foundation was used in the tank structure. The service tank was seriously damaged and completely lost its function.

Figure 1 Split of top slab from expansion joint

Beam-column system structure of reservoir were partly damaged due to extra shear force and moment produced by foundation displacement. To remove and reconstruct a new reservoir is more possible choice because the structure was seriously damaged and the function was completely lost.

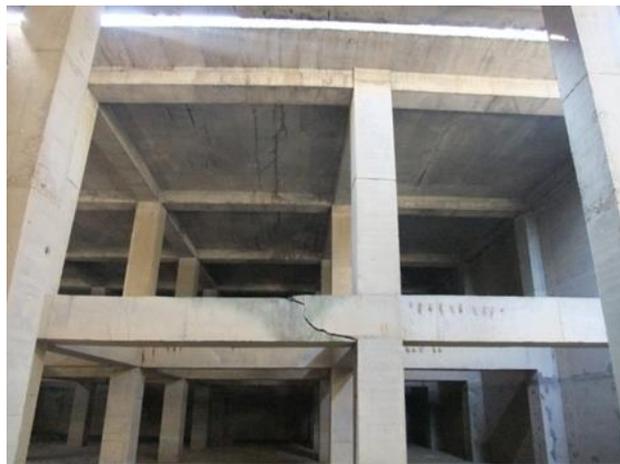
Figure 2 Break in the joint of beam-column joint

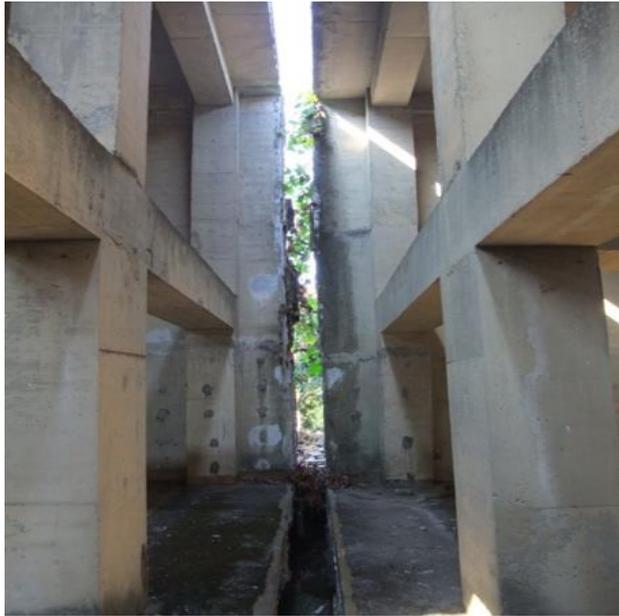
Figure 3 Split of basin from expansion joint

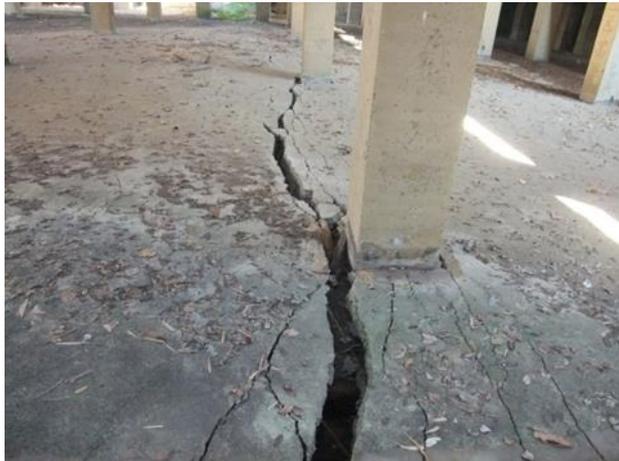
Figure 4 split of bottom slab

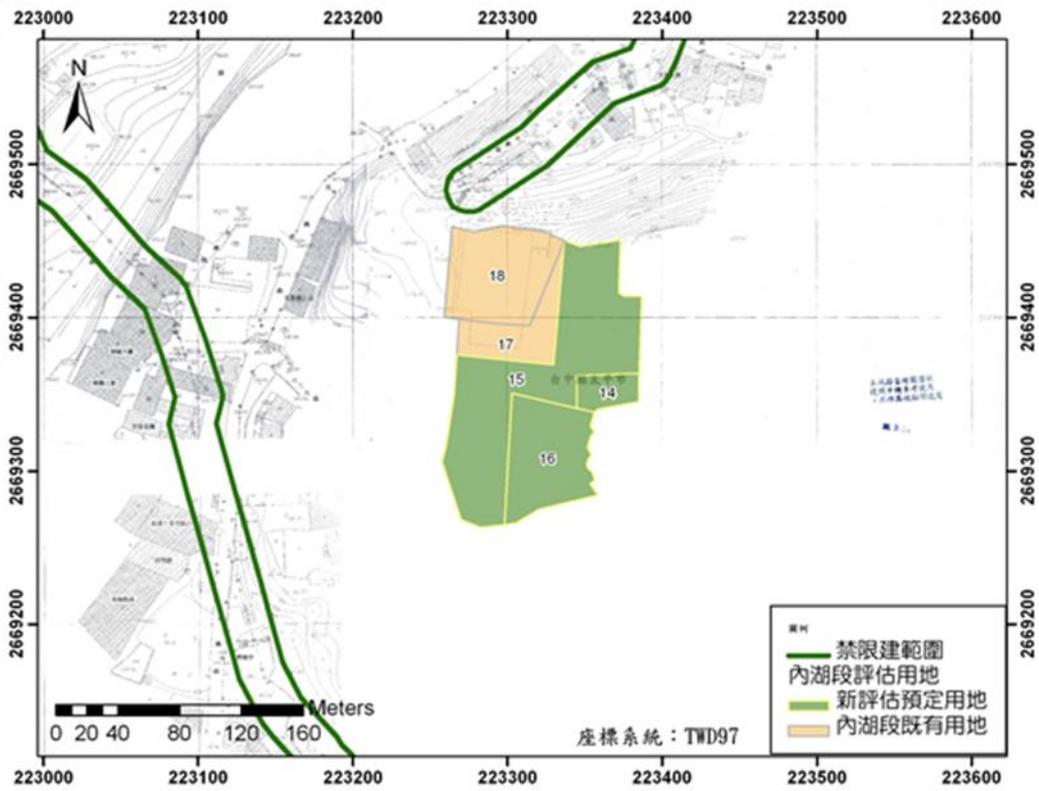
According to the No.762 meeting record of urban planning committee, both sides within a 15 m limit Che-Long-Pu geological fault line is banned for building.

The distance after mapping is only 10 m between Nao-Guan storage tank site and Che-Long-Pu geological fault limit region. as shown in figure 5.

To summarize the results of evaluation, if choose to rebuild Nao-Guan reservoir at original site, it is needed to propose soil conservation plan and execute site geological investigation and safety evaluation, although environmental impact assessment is not necessary to implement. On the other hand, it is only 15 m distance between Nao-Guan reservoir and Che-Long-Pu geological fault limit region, although not within the limit region.

Figure 5 Relative location of reservoir site and region of Chelongpu fault

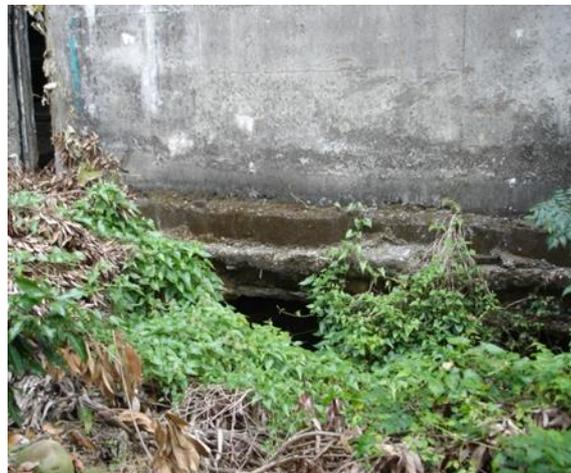
Again, from picture 6 and 7, it is shown that there is an obvious exposed stratum and ground rupture in the surrounding surface of reservoir. It can be forecasted that if reconstruct reservoir at the original site, it is very possible to have a serious damage when there is an another earthquake happened.

Figure 6 Rupture of ground in the surrounding surface of reservoir.

future operation requirement, geological feature, regulation limits and economics. After detail evaluation, repairing the damaged reservoir or reconstructing reservoir at the original site is not suitable. Finding a site to construct a new reservoir is a better proposal.

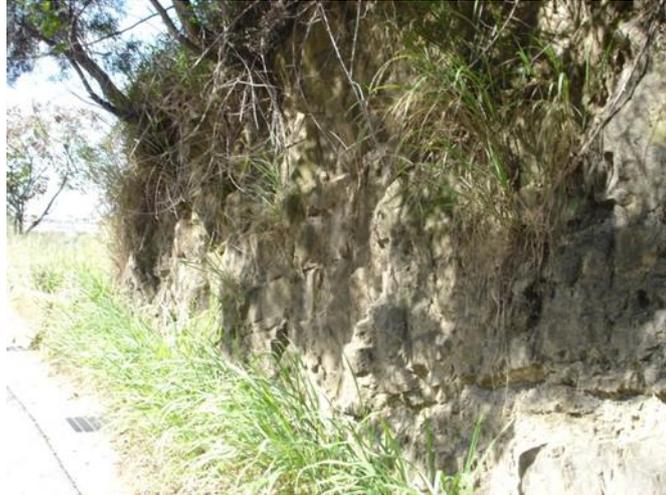
Figure 7 Obvious exposed stratum in the surrounding surface of reservoir.

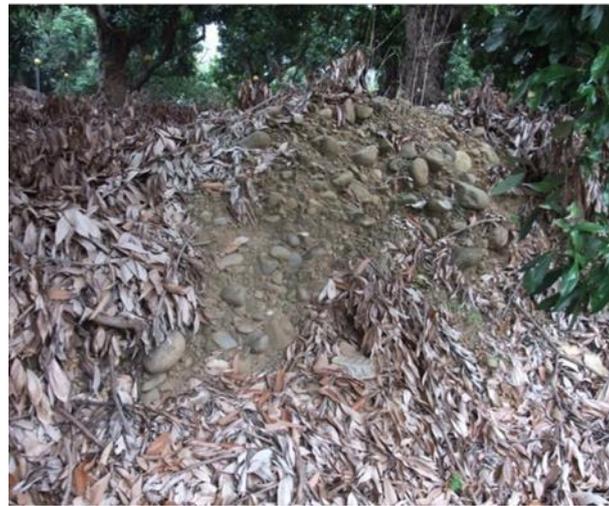
Nao-Guan reservoir is located at hillside, its elevation is 128 m. There is a 3 m pebble and gravel lay on the top of soil (Figure 10), rock characteristic is siltstone intersperse with thin shale strata (Figure 11). This rock stratum is mild to middle weathering, and stratification of stratum is still clear to be identified. The relative position of Che-Long-Pu geological fault and Nao-Guan reservoir is shown in Figure 7. From the point of geological condition view, the site of original Nao-Guan reservoir is located in active geological fault susceptible region, and it is not suitable to reconstruct reservoir in the original site.

Figure 10 A 3 m pebble and gravel lay on the top of soil

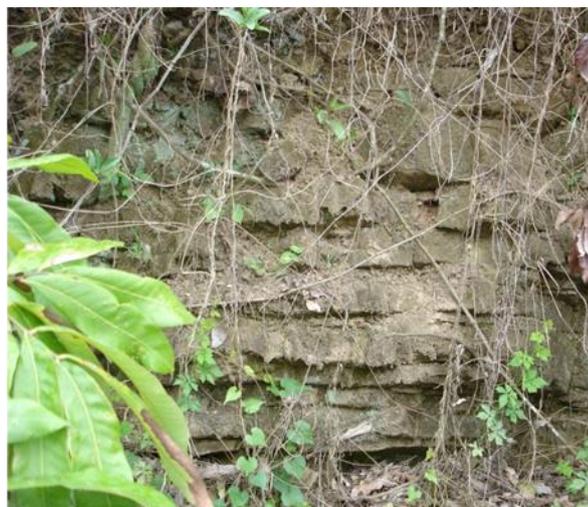
Figure 11 Siltstone intersperse with thin shale strata in the vicinity of reservoir
