Damage of water works facilities caused by the Great East Japan Earthquake and future problems for reconstruction in Otsuchi Town

Koji Kurihara , Kimiyasu Ohtake
NJS CO.,LTD. Tokyo General Office Water Supply Division

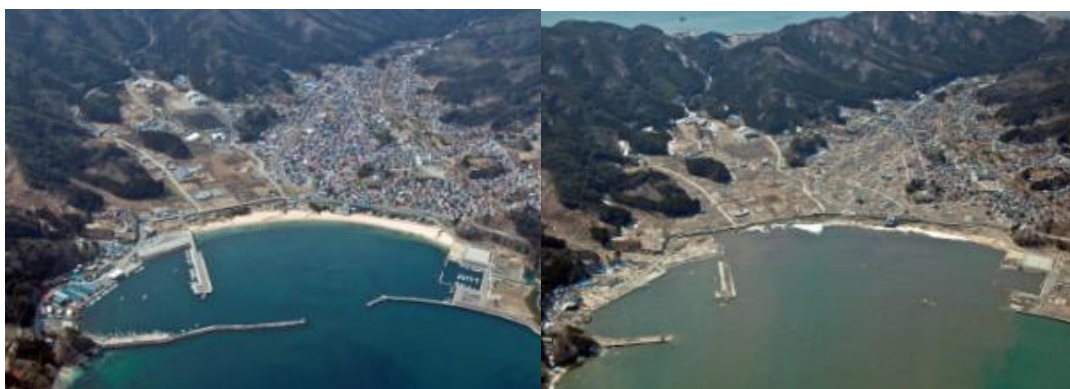
Figure 3 Aerial view of the center of Otsuchi Town (left) before and (right) after The Great East Japan Earthquake.

The Great East Japan Earthquake devastated coastal cities due to the associated tsunami, including a long-term disruption to the water supply. The majority of Otsuchi Town residents lived along the coast. The toll included 809 dead, 423 missing, (as of June 1, 2015)⁴, and 4,167 houses destroyed (as of May 31, 2011). The earthquake itself caused little damage compared to the accompanying tsunami, which caused massive flooding that was responsible for most of the damage.

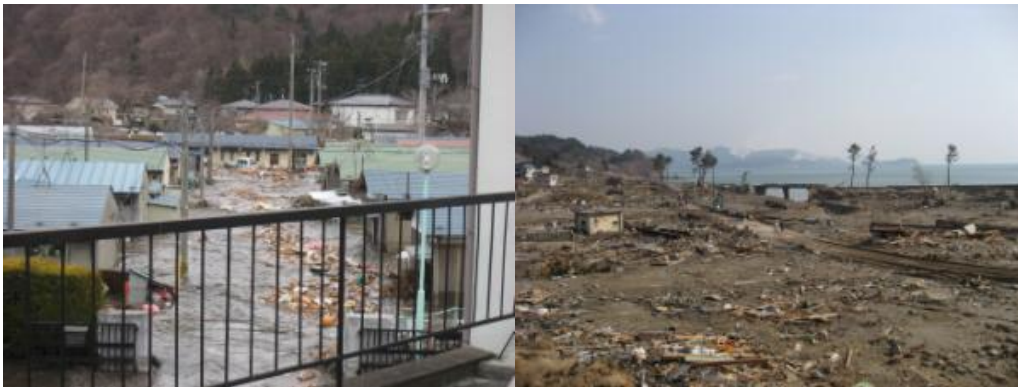
Figure 4 Damage to (left) the water purification plant and (right) the Namiita pumping station .

- Household effect: 5,605 households experienced an interruption with their water supply⁶⁾
- Water purification plant: The tsunami hit the water source (well) for the Ogakuchi pumping station within the water purification plant, raising its water level. Although tsunami damage was not inflicted, if the water level had risen another 40 cm, the water purification plant would have been completely shut down. The non-utility generation facility was also spared damage. These facts made the water purification plant the center for water supply activities after the earthquake.

- Pumping station damage : Three booster pumping stations were completely shut down.
- Distribution pipes damage: 58 km of 107 km of water transmission (delivery) pipes were nonoperational.
