# Report on the seismic reinforcement work of Sagamihara Sedimentation Basin

Construction Section, Facilities Department, Yokohama Water Works Bureau  
SUZUKI, Tomomi

Sagamihara Sedimentation Basin is a structure of the earth-fill dam type for removing suspended solids in raw water via deposition. In FY 2011, the bank was inspected for seismic resistance. The inspection showed that the main bank lacked the required seismic resistance on the side facing the basin (referred to as the “upstream face”).

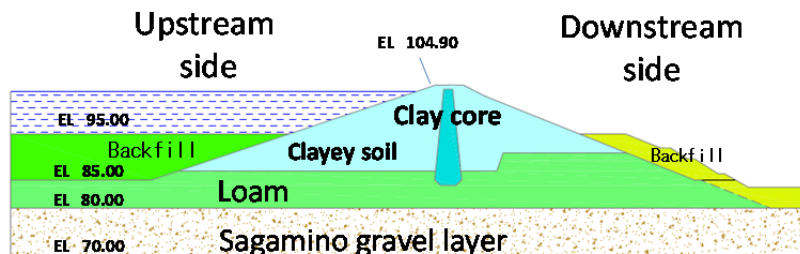
Fig. 2.3 Representative sectional view of Sagamihara Sedimentation Basin

pipeline shown in Fig. 2.3. However, there are no sedimentation facility between Nishiya Water Purification Plant and Sagamihara Sedimentation basin. This would lower the performance of water treatment in the event that the turbidity of the raw water increased, for instance during a typhoon or a storm. Therefore, water could not be sent solely through the bypass pipeline over a long period of time.

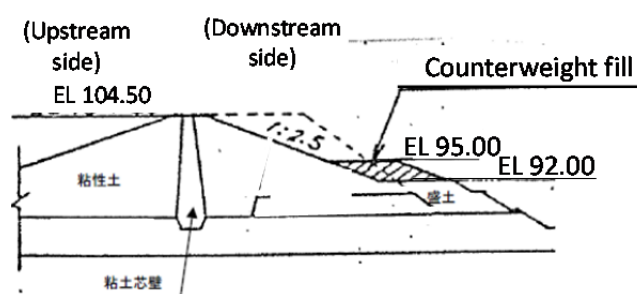
Fig. 3.1 Outline map of the retrofit work

Yokohama Water Works Bureau examined the seismic resistance of Sagamihara Sedimentation Basin in 1982 and discovered that the slip surface of the downstream face of the main bank lacked seismic resistance. Therefore, the main bank was retrofitted by cutting and installing counterweight fill along the downstream face of the bank (Fig. 3.1). Later, in 1997 and 2009, the Seismic Design Guideline for Water Works Facilities (hereinafter referred to as the "Guidelines") was revised requiring for a raised seismic resistance level. Because there are a university and Sagamihara Park, which is a governmentally designated evacuation site at the time of disaster, near the

basin, collapse of the bank was feared to lead to secondary damage and affect people and properties. A dam which had a structure similar to that of this basin collapsed in the Great East Japan Earthquake. Therefore, the seismic resistance of the basin was

checked based on the Guidelines (2009). The main bank was found to not have the required seismic resistance, and retrofit work started in 2013.

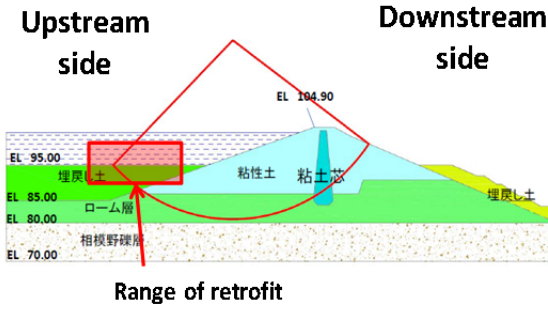
<p>Plan of the range of retrofit</p>

Plan A involves emptying the basin and retrofitting the upstream side. As described above regarding constraints on ground conditions (③), the bottom surface of the basin was suspected to develop cracks and leak water. To empty the basin, it was necessary to solely use the bypass pipeline, but water could not be sent solely through the bypass pipeline over a long period of time as described in the constraints on water quality (②). Therefore, Plan A was rejected.

Plan B involves closing the area to retrofit by installing a temporary structure such as steel sheet piles and retrofitting the upstream side. However, as mentioned in the constraints on ground conditions (③), installation of a temporary structure was suspected to cause cracks on the bottom surface of the basin. Therefore, Plan B was rejected.

Plan C involves separating the area to retrofit by installing an underwater curtain and retrofitting the upstream side. However, insertion of the retrofitting materials was suspected to stir up sediments on the bottom of the basin and deteriorate the quality of water. Because the plan does not meet the constraints on water quality (②), Plan C was rejected.

It was thus judged very difficult to retrofit the upstream face.
