The Damaged Water Supply Facility for Repair or Reconstruction Evaluation Program – A Case Study of Nao-Guan Service Reservoir at Taichung, Taiwan

Case study : The renovation proposal of Nao-Guan storage tank.

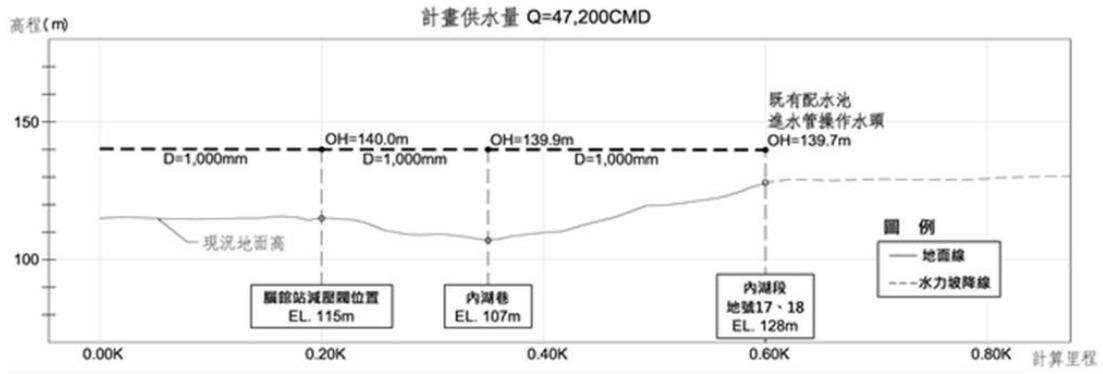
The network hydraulic analysis of average daily demand in Tai-Ping in 2021 is shown in Figure 8, hydraulic analysis of Nao-Guan reservoir is shown in Figure 9. Nao-Guan reservoir elevation is 128 m, the high water level and low water level of design is 129 m and 122.5 m respectively. There is a 1000 mm distribution pipe between pressure-reducing value and this service reservoir, and its distance is 250 m long. The operation head is 140 m before pressure-reducing value, and the operation head is 139.7 m in reservoir inlet.

Figure 8 Network hydraulic analysis of average daily demand in Tai-Ping in 2021
